# MAKING A BOAT RECYCLABLE PROTOTYPE

Prepared by Daniel Poirier, ing.  
Composites Development Centre of Québec

As part of a collaborative project with Innovation Maritime (IMAR), a prototype boat made of recyclable composite materials was built. The objectives of the IMAR/CDCQ project were to study the performance of recyclable materials in the design of ships. In order to create a product that meets eco-design principles, the manufacturing process of the demonstration boat was completely rethought. To allow the replacement of elements that are difficult or not recyclable (wood, core, polyurethane foam), the structure was manufactured differently. Here are the details of the manufacturing of the proposed boat according to a recyclable design.

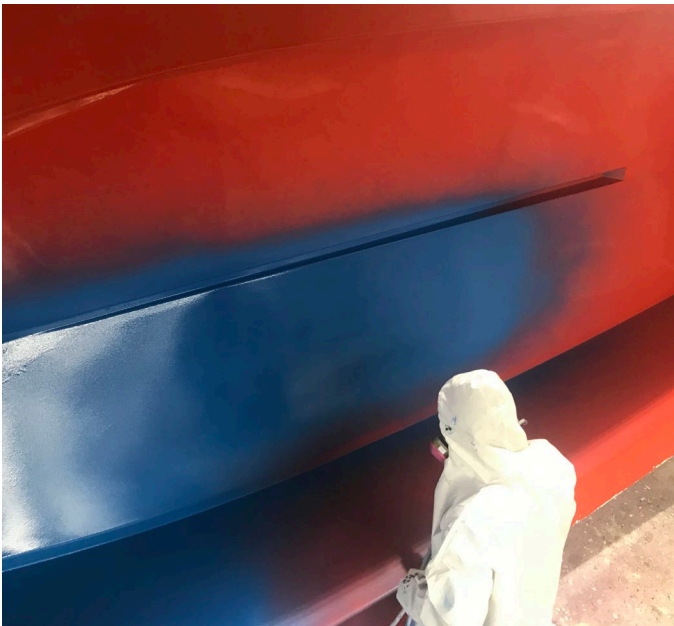
First, an NPG-isophthalic polyester gelcoat (AOC Vibrin G315AC) was applied in the mold as an aesthetic layer (Figure 2).

*Figure 2. Application of gelcoat in the hull mould*

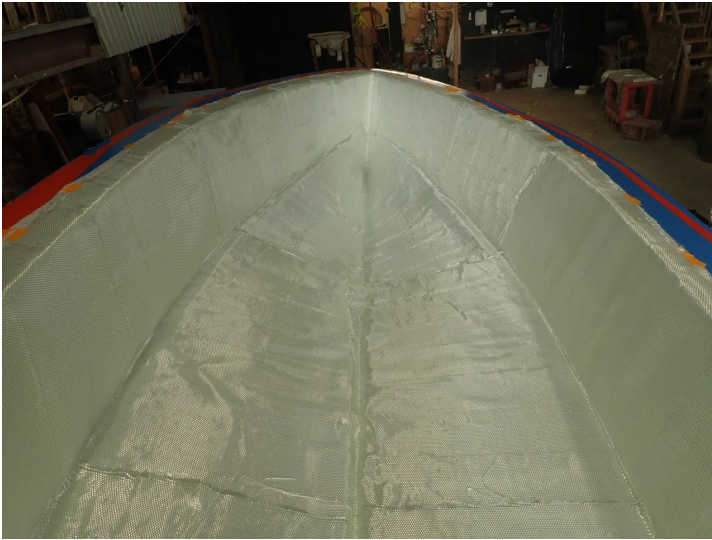
Afterwards, the bagging materials (release film or peelply, infusion medium, tubing, sealing tape and sealing bag) were placed (Figures 4, 5 and 6) and then the laminate was vacuum infused with Arkema Elixir™ 1880 resin. Once the resin was cured, the part was demolded, and the periphery was cut out.

*Figure 4. Positioning of the reinforcements in the hull mold*

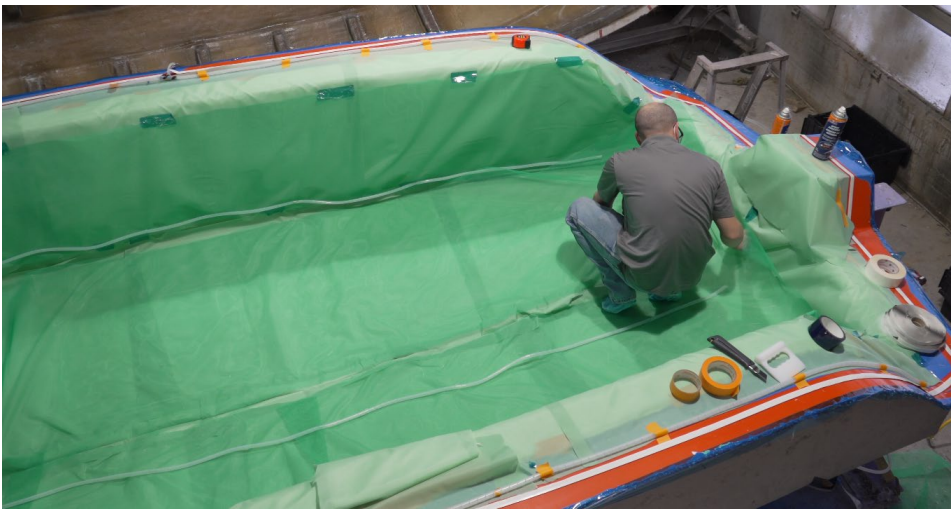
*Figure 5. Positioning of release film, medium and infusion lines*

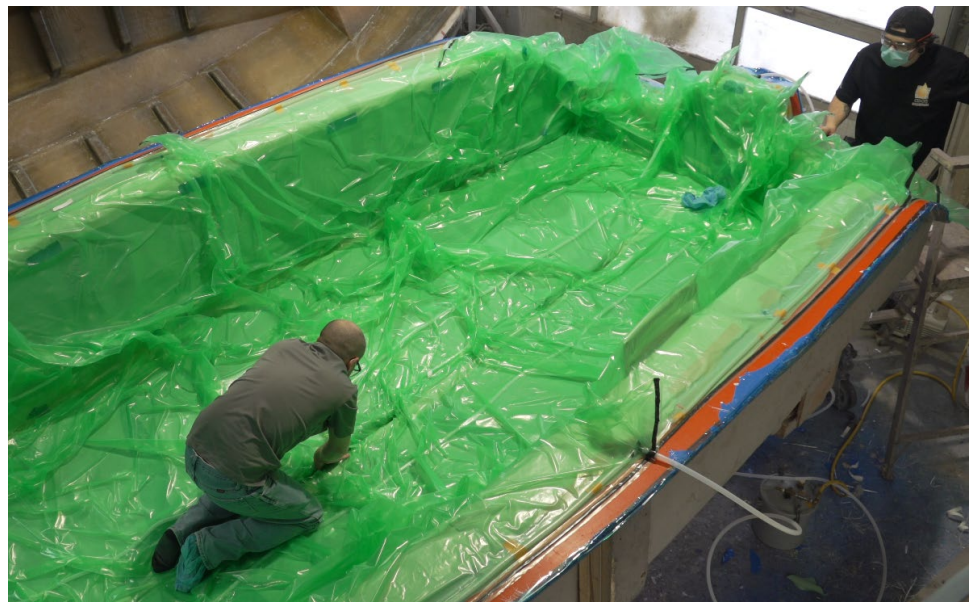
*Figure 6. Bagging and infusion of the shell*

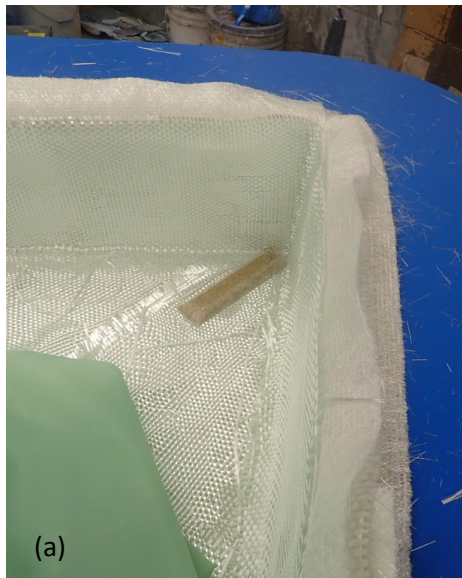
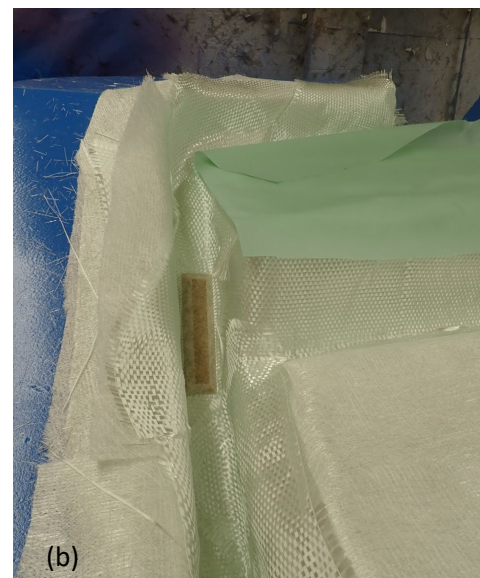
To replace the wood cores in the bench area, stiffeners were added in the fabrication. Molding jigs (Figure 9) were used to infuse these stiffeners into the deck laminate. For the inking inserts (Figure 10), also previously made of wood, plates of thermoplastic composite materials containing recycled materials were prefabricated. These plates were then cut and integrated into the laminate.

*Figure 10. Recycled composite inking inserts - (a) front, (b) rear*

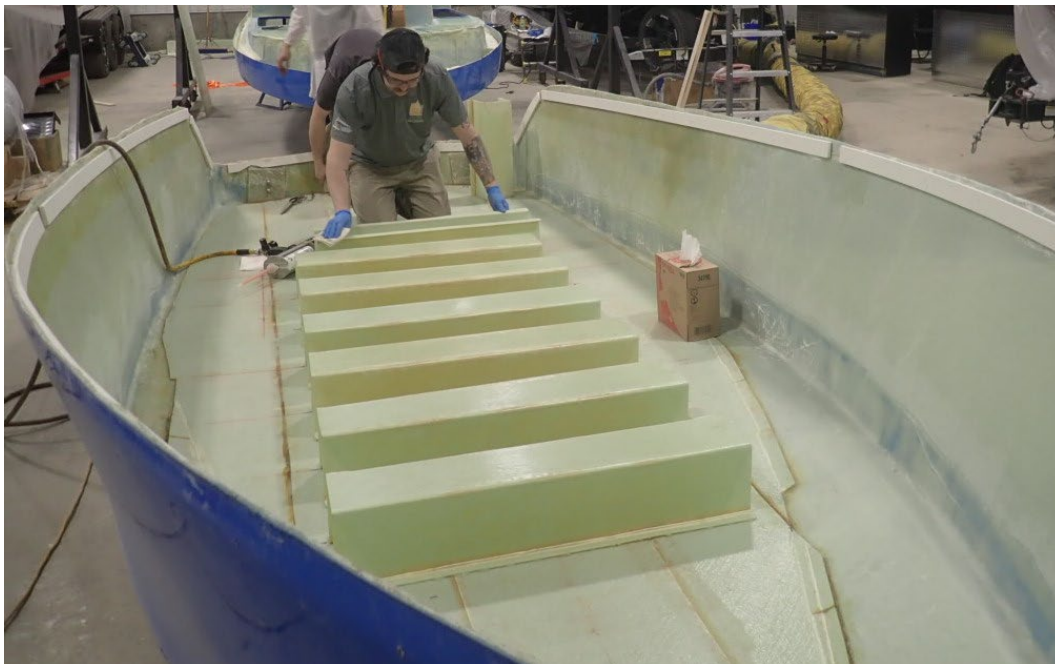
*Figure 14. Assemblage de la sous-structure de la coque*

Following the manufacturing of the main parts (hull, deck, caissons and reinforcements), we realized the assembly of the boat and its substructures. The box and reinforcement parts previously produced were adjusted and assembled by gluing in the hull (Figures 12 to 15). An acrylic-based adhesive from Bostik was used for these operations. This adhesive was selected based on its recyclability with the rest of the construction.

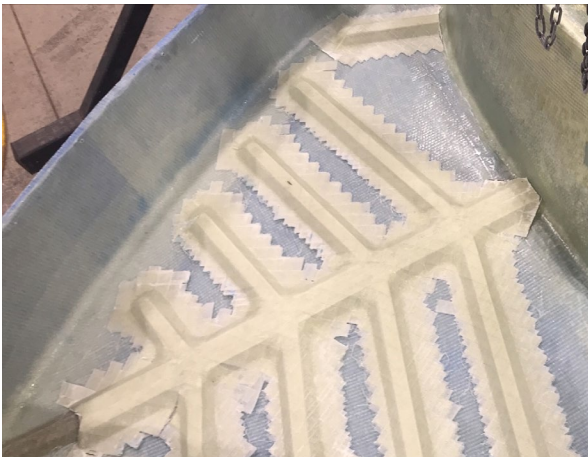
*Figure 19. Gluing of the front sub-deck reinforcement*

The fir tree shaped front sub-deck stiffener was made with a preform produced flat using a robotic cell (Figure 17). We validated this manufacturing method because it minimizes material loss during manufacturing. This fiberglass preform was then infused with Elium™ resin on a prototype mold with the desired geometry (Figure 18). This part along with the omega stiffeners were bonded to the inner surface of the bridge during assembly (Figures 19 and 20).

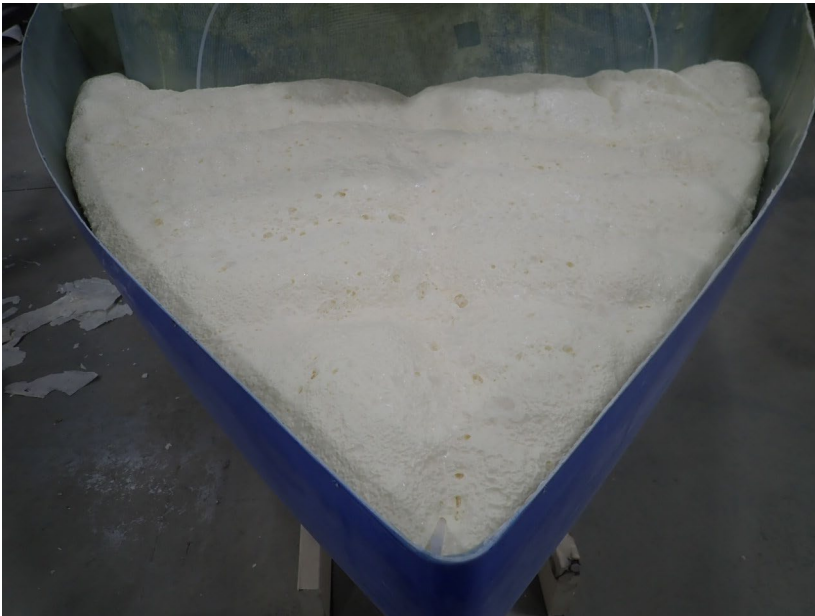
To obtain the desired flotation characteristics of the boat, an acrylic foam was added in the hull and in the deck. This low-density foam was specifically formulated and developed for the project for the recyclability aspect. Typically, the foam used in the manufacture of boats for flotation is a polyurethane. For the hull, the foam was integrated under the caissons while for the deck, the front and side parts were foamed (Figures 21 and 22).

*Figure 21. Flotation foam in the front part of the deck.*

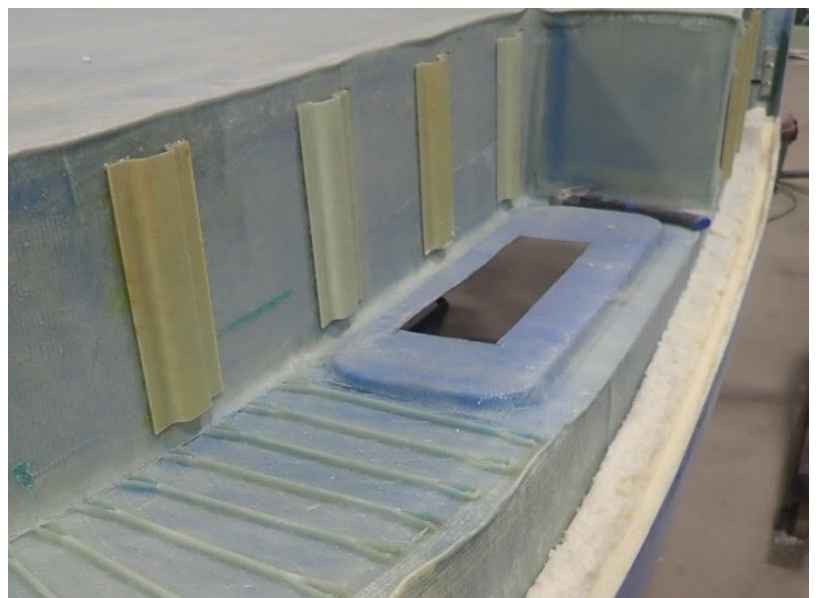
*Figure 22. Flotation foam on the sides of the deck*

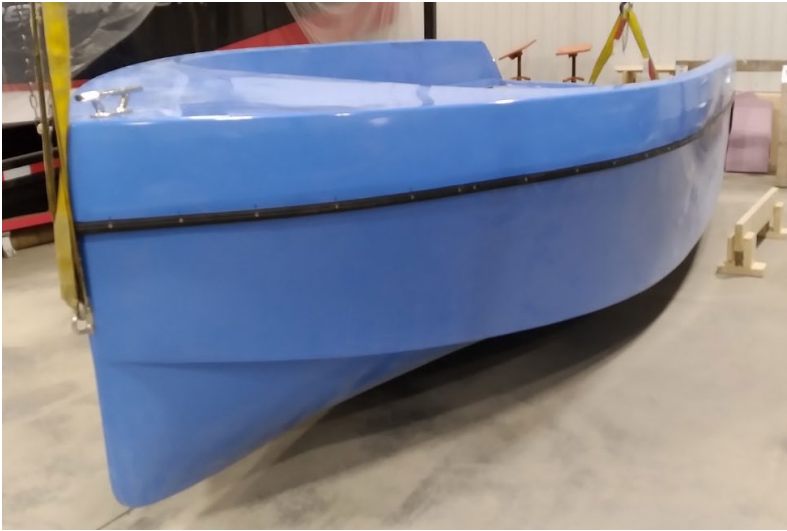
Once all the manufacturing operations were completed, the two main parts were joined together by adjusting the contours of the parts as needed. An undercut was installed at the intersection of the two parts using stainless steel screws to mask the joint between these parts and ensure the assembly of the hull and deck. The openings in the thwarts were completed and the finish of the boat was reworked to repair certain imperfections and ensure an aesthetic piece. Finally, the moulding and some accessories were installed.

*Figure 23. Assembling the boat*

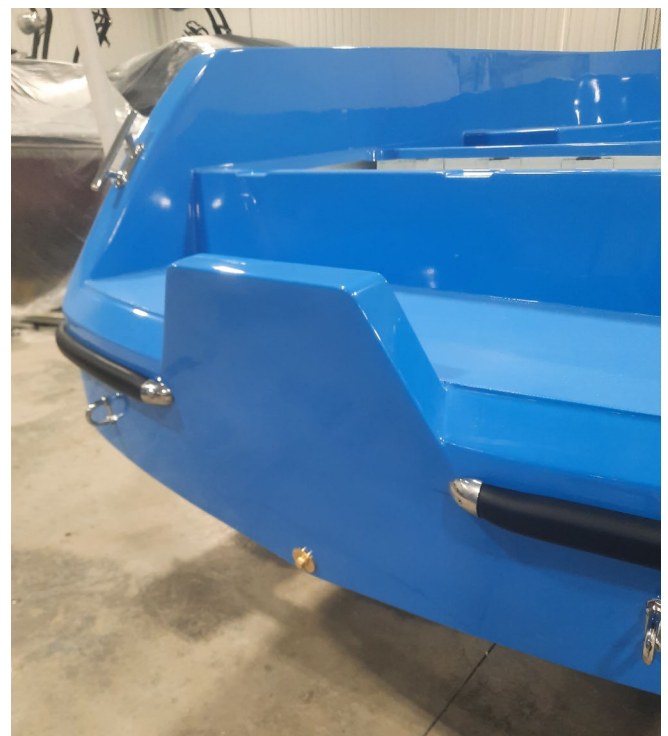
*Figure 24. Finition du bateau (avec accessoires)*

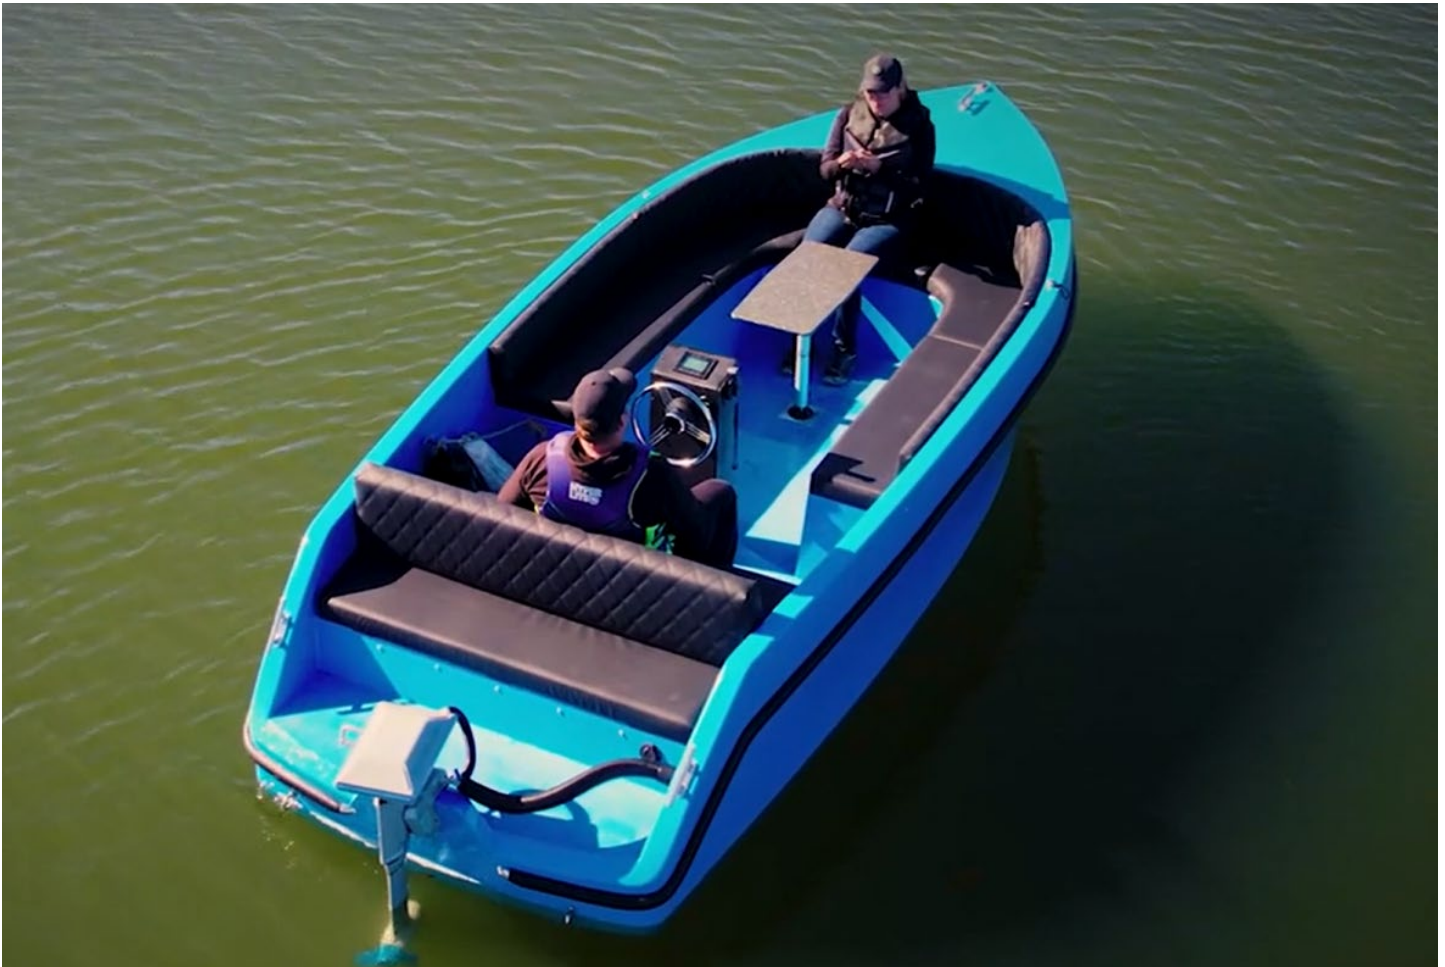
Once the CDCQ completed the composite material portion of the recyclable boat demonstrator, the prototype boat was transported to IMAR for the trim of the latter with the other essential components (steering, motorization, etc.). The installation of the console and the finishing of the cockpit were done by IMAR. The choice of materials and ease of disassembly were taken into account for easy future dismantling. The table was also produced from recycled composite materials. An electric motorization was installed and then tests on water were carried out (Figure 25).

*Figure 25. Recyclable boat*
